Manhole Inspection Summary

Manhole # S21M__015MH

Insp Date: **2/24/09 10:34 AM**

Location Address: **1850 EAGLE ST**

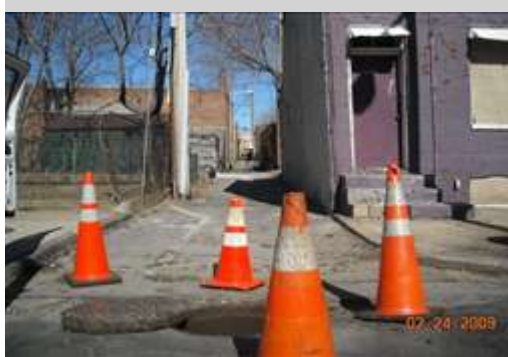
Location View

Comments **HEAVY CLEANING FROM DOWN STREAM MANHOLE S21M__022MH TO REMOVE
GREASE DEPOSITS AND ALEAVIATE SURCHARGE; ASPHALT IS SETTLED AND
CRACKED AROUND FRAME**

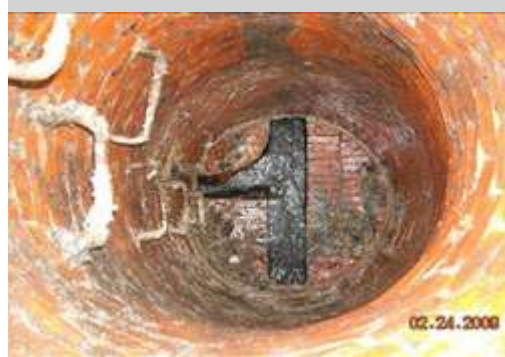
Top View

ASPHALT CRACKED IN SHAPE OF FRAME
